# **Management of Aquatic Warbler breeding habitats in Belarus**

**- experiences and conclusions**

## **Implementing urgent conservation actions in mesotrophic fen mires in Belarus**

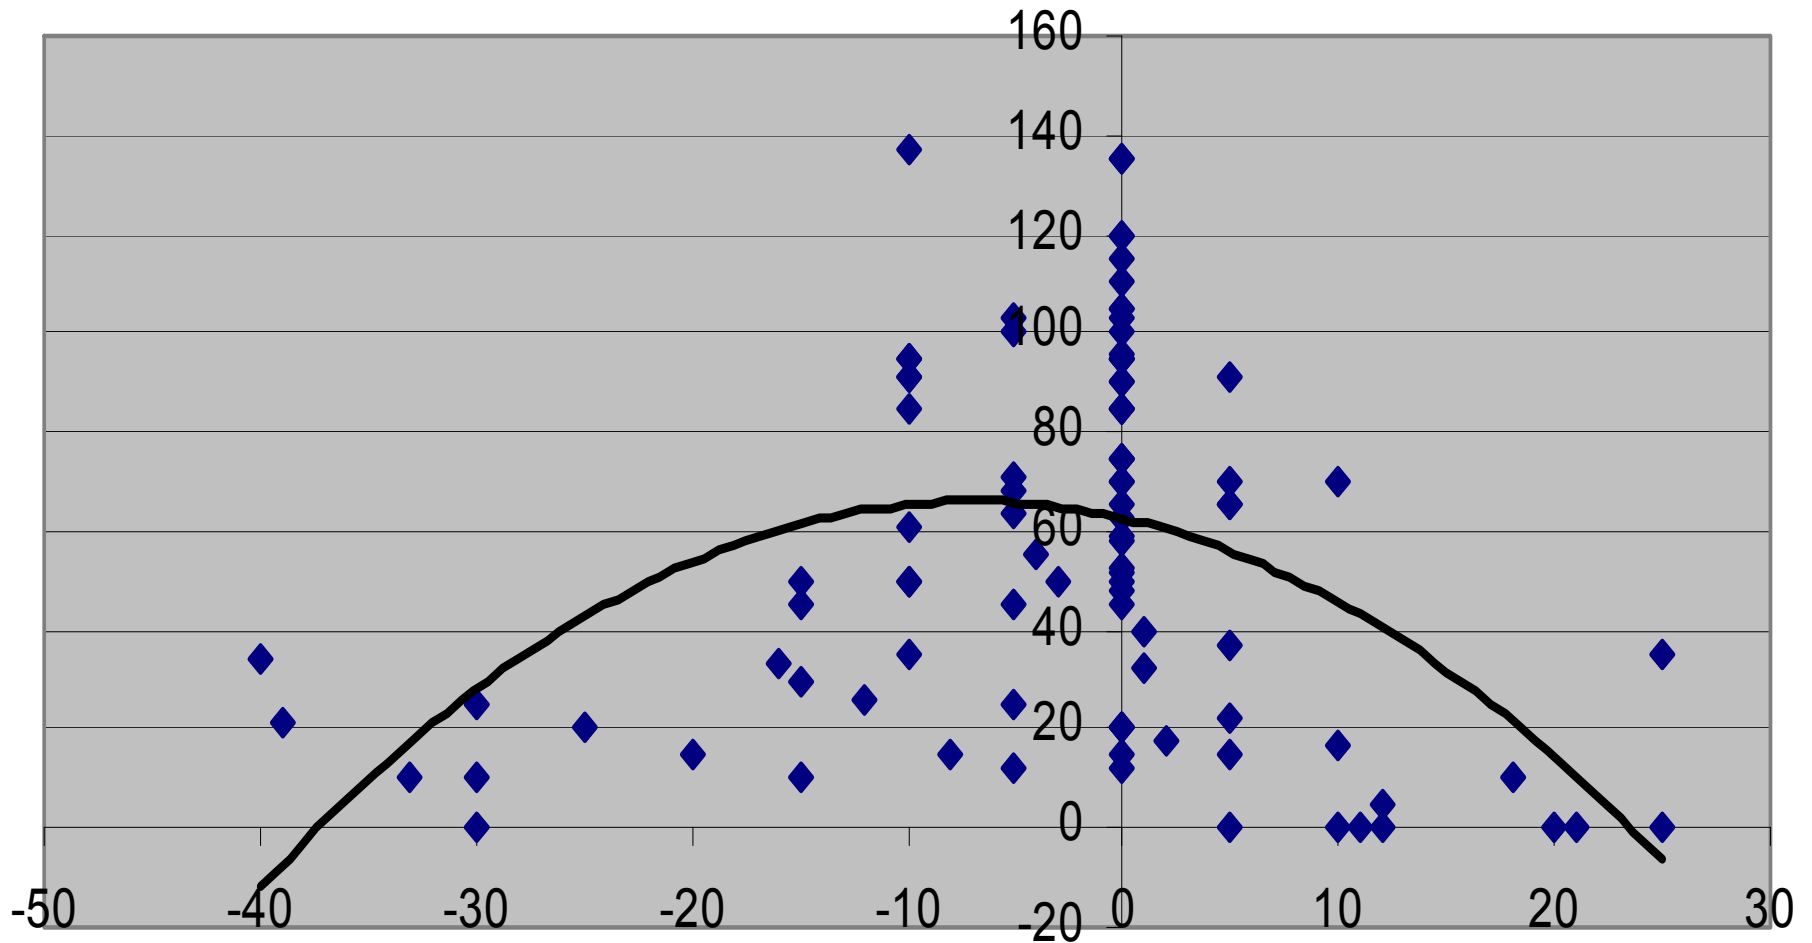
# The correlation between water level and density of signing males.

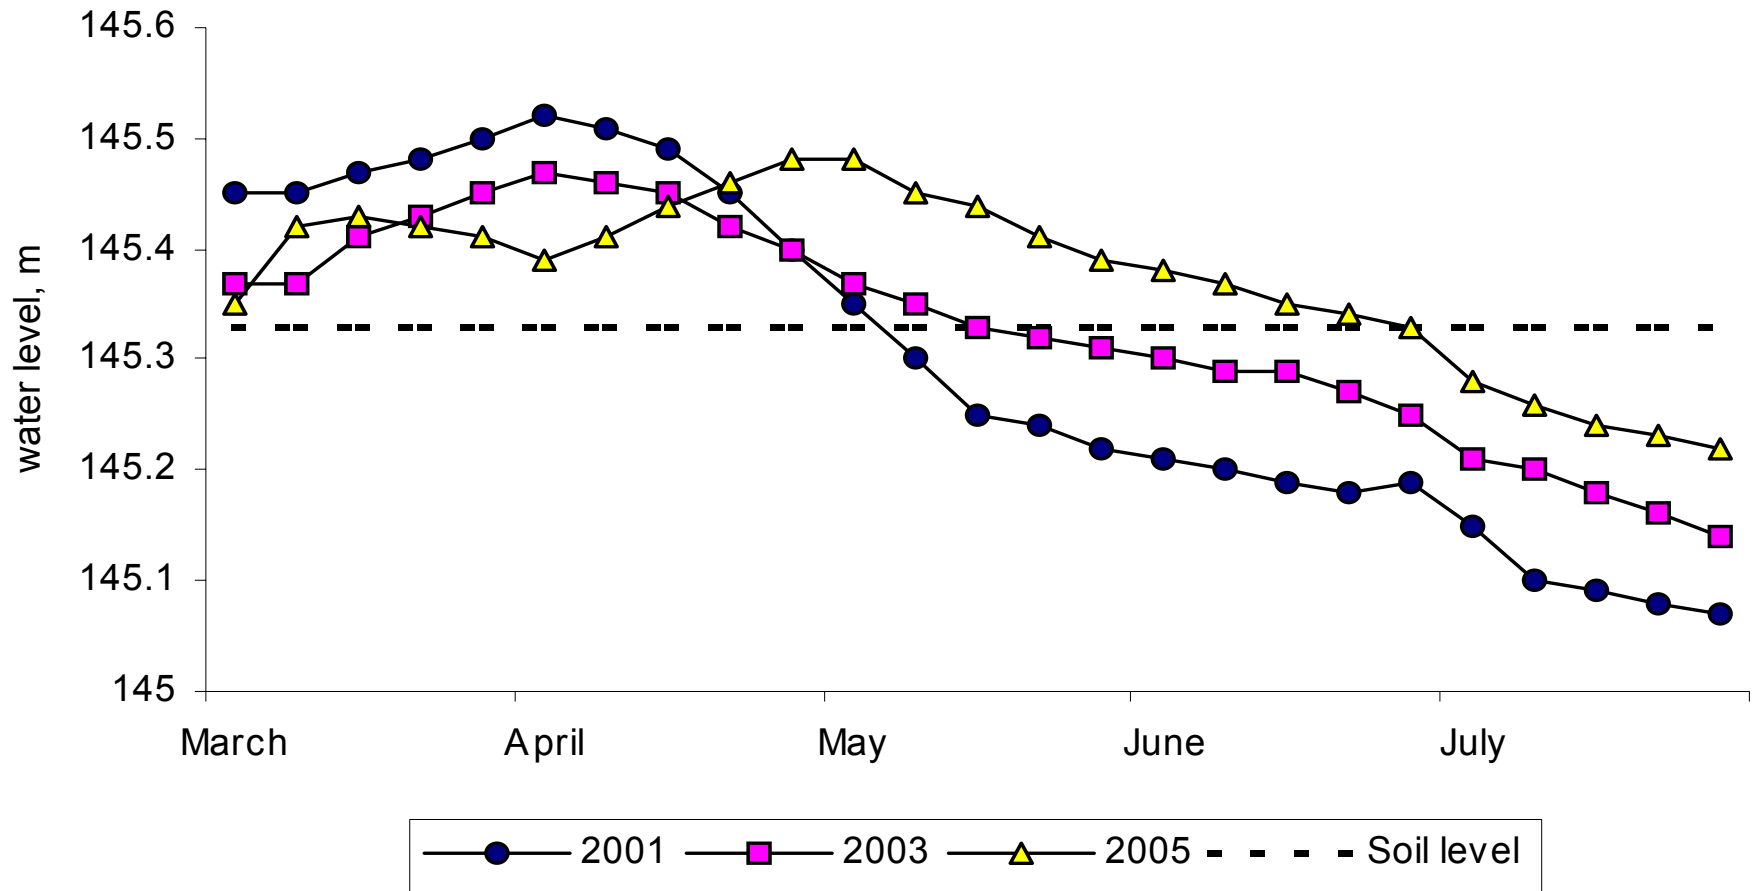
# Monitoring of water level at Zvaniec mire

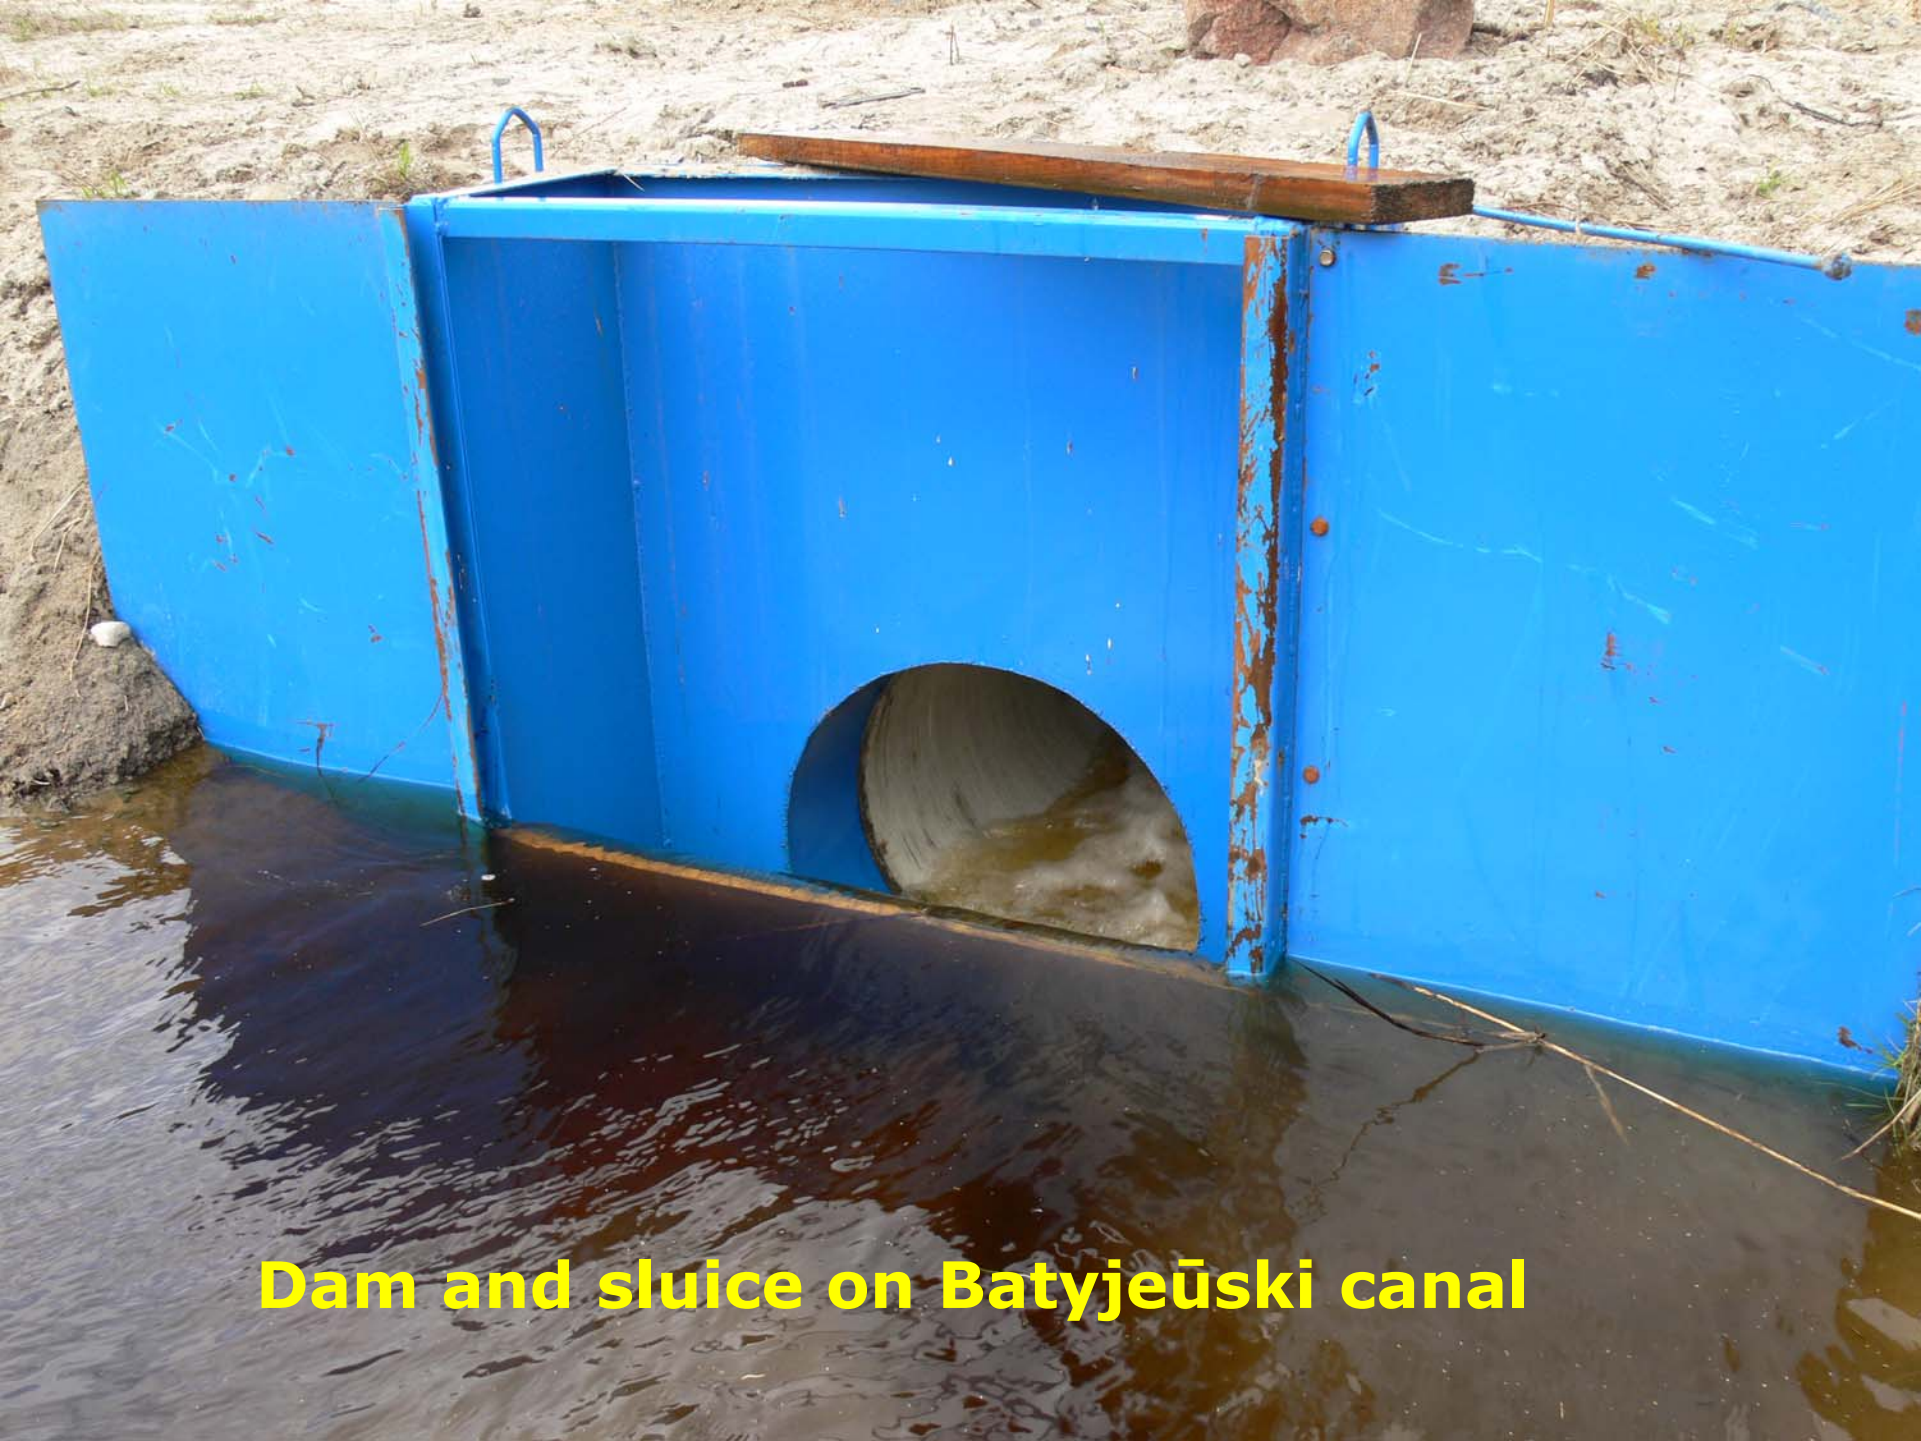
**Dam and sluice on Batyjeŭski canal**

3. For all three sites, water management was deemed as priority action and several conservation projects targeted restoration of hydrological regime of these sites, resulting in construction of 13 sluices and dams (6 at Dzikaje, 6 at Zvaniec, 1 at Sporava).

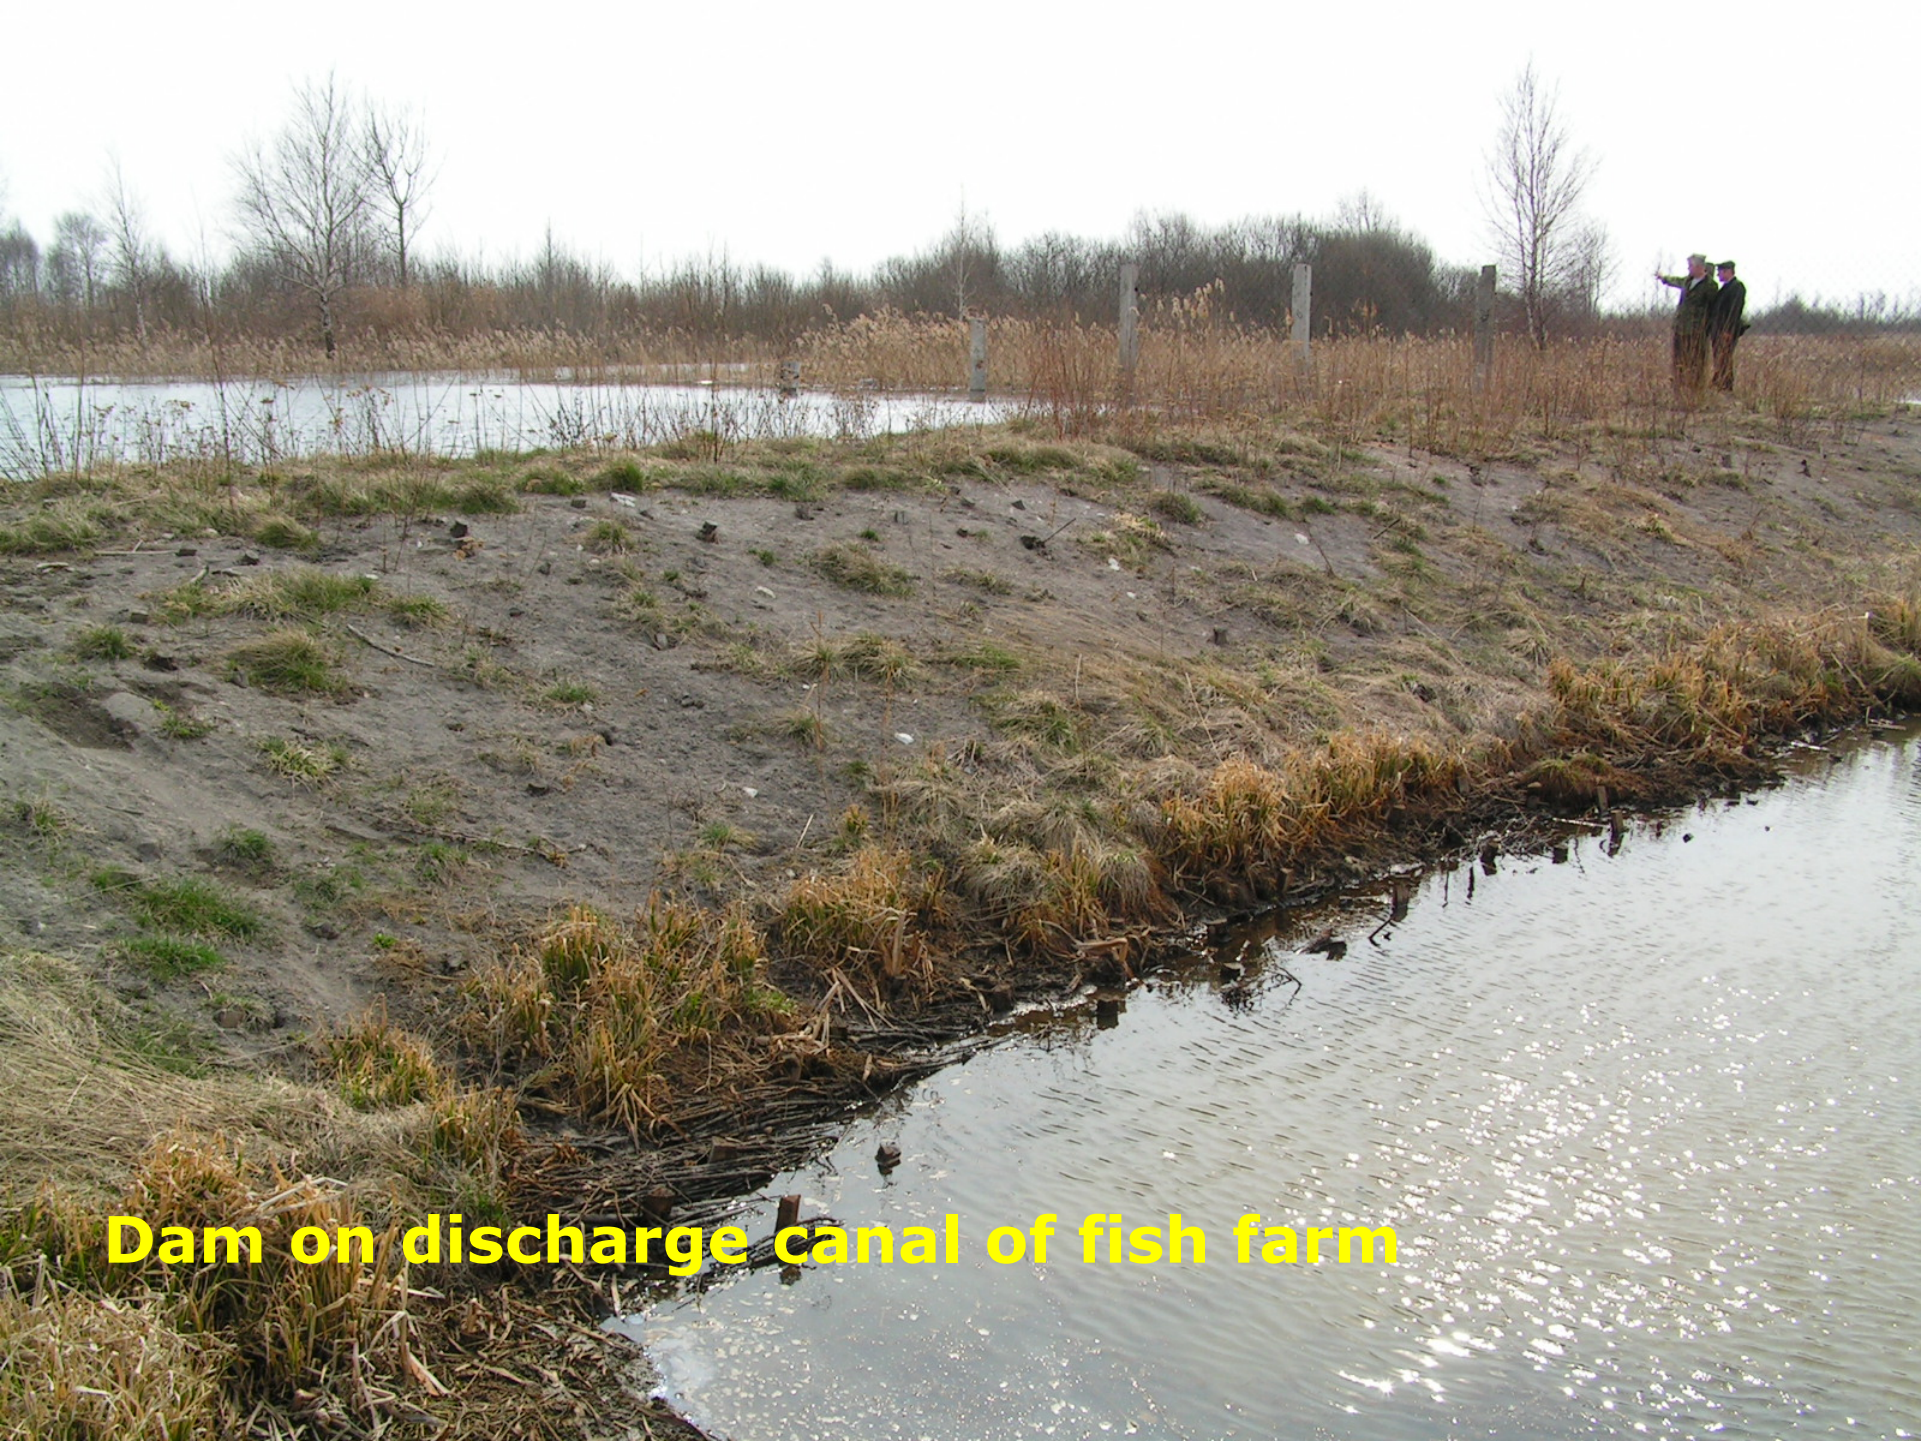
**Dam on discharge canal of fish farm**

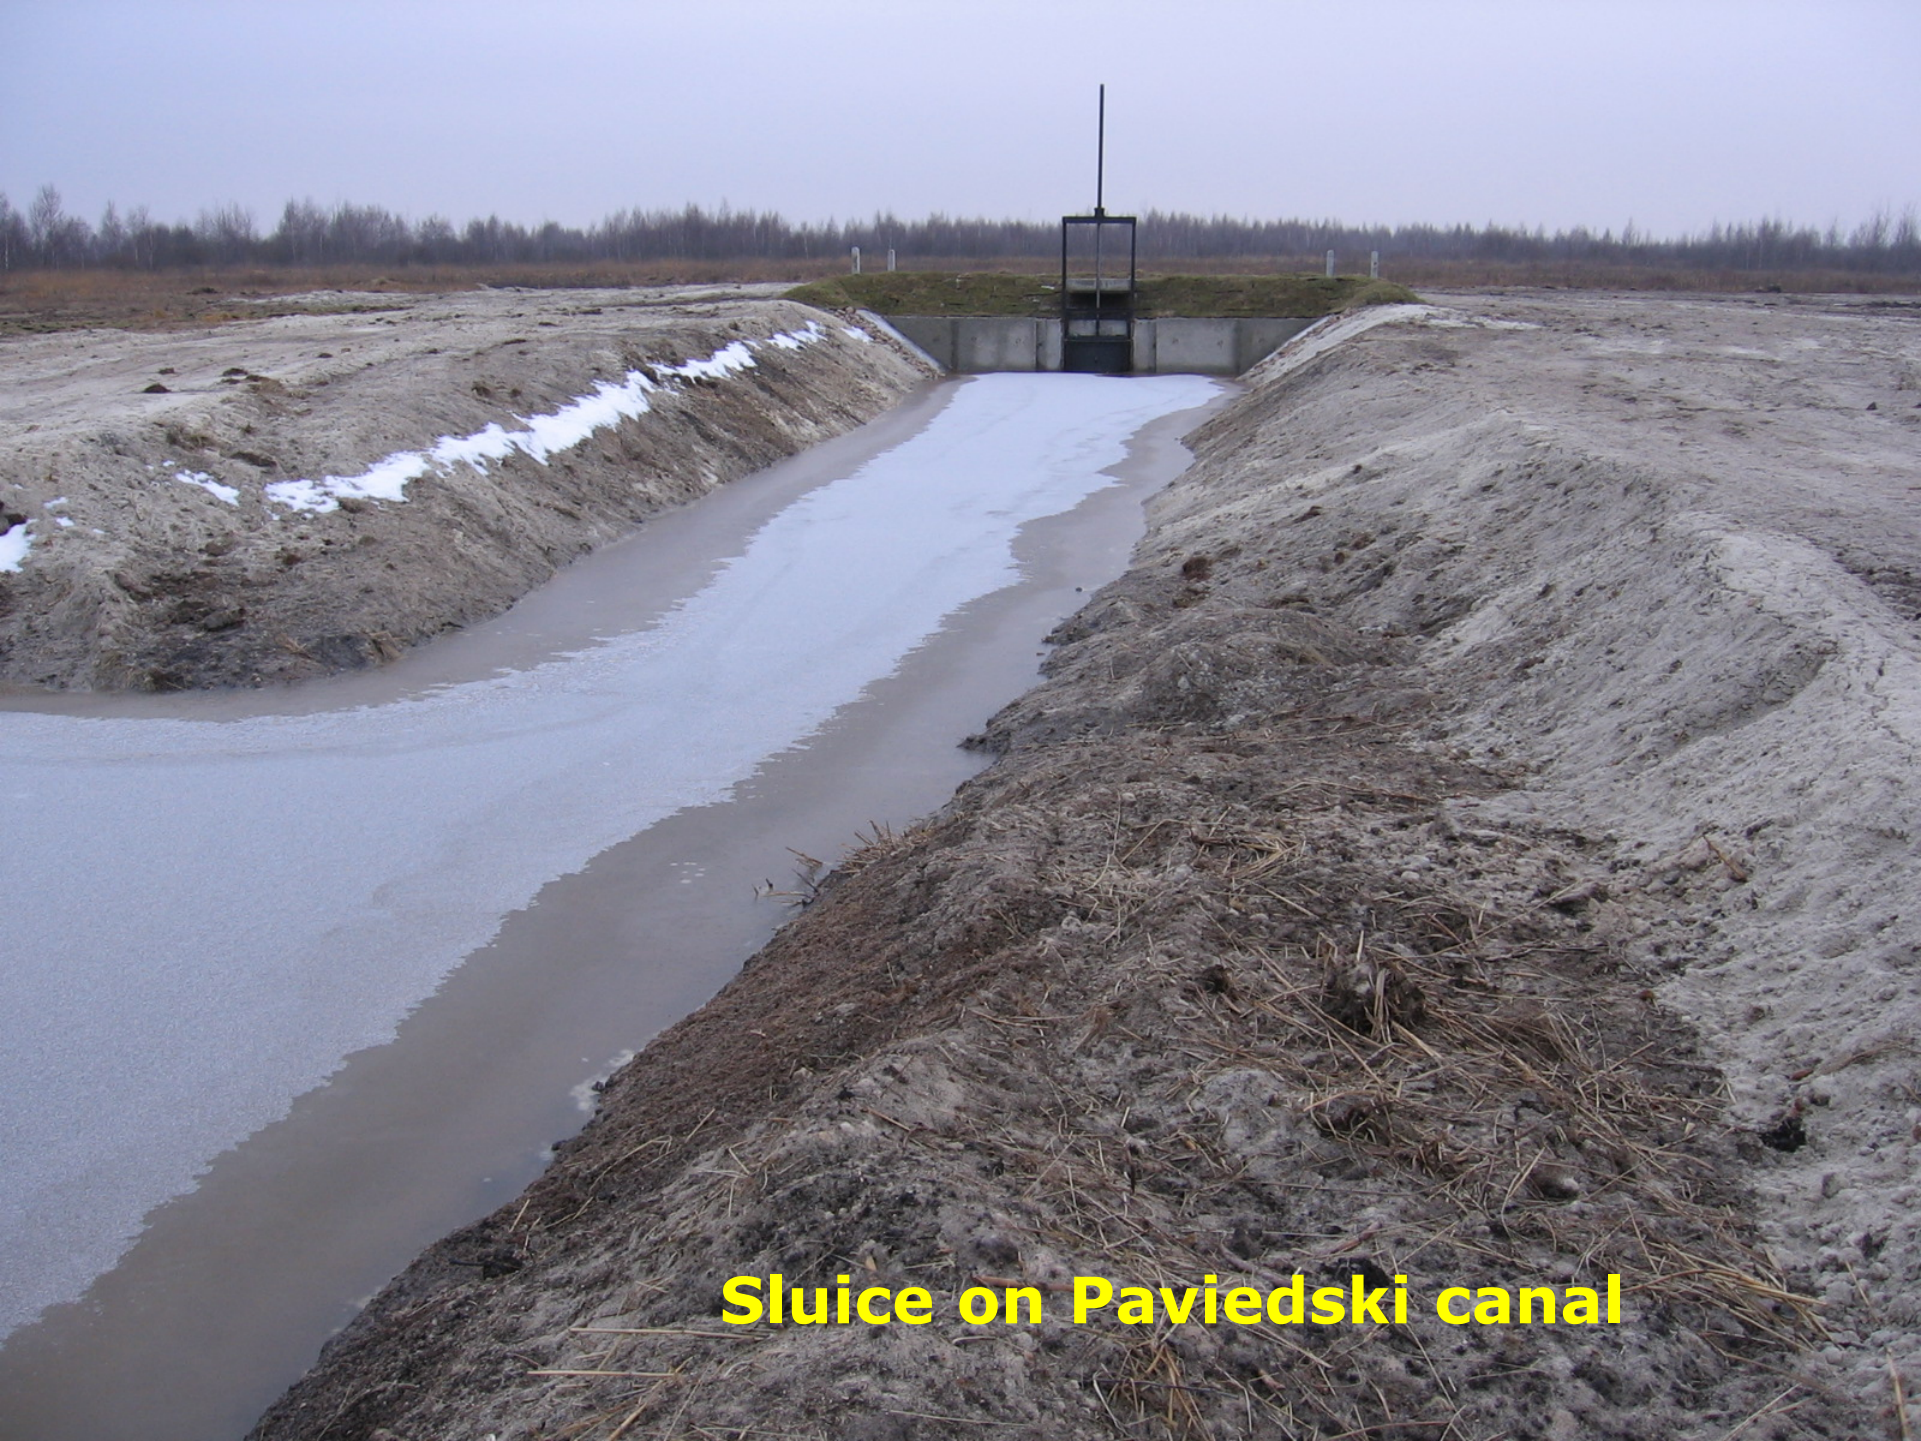
**Sluice on Paviedski canal**

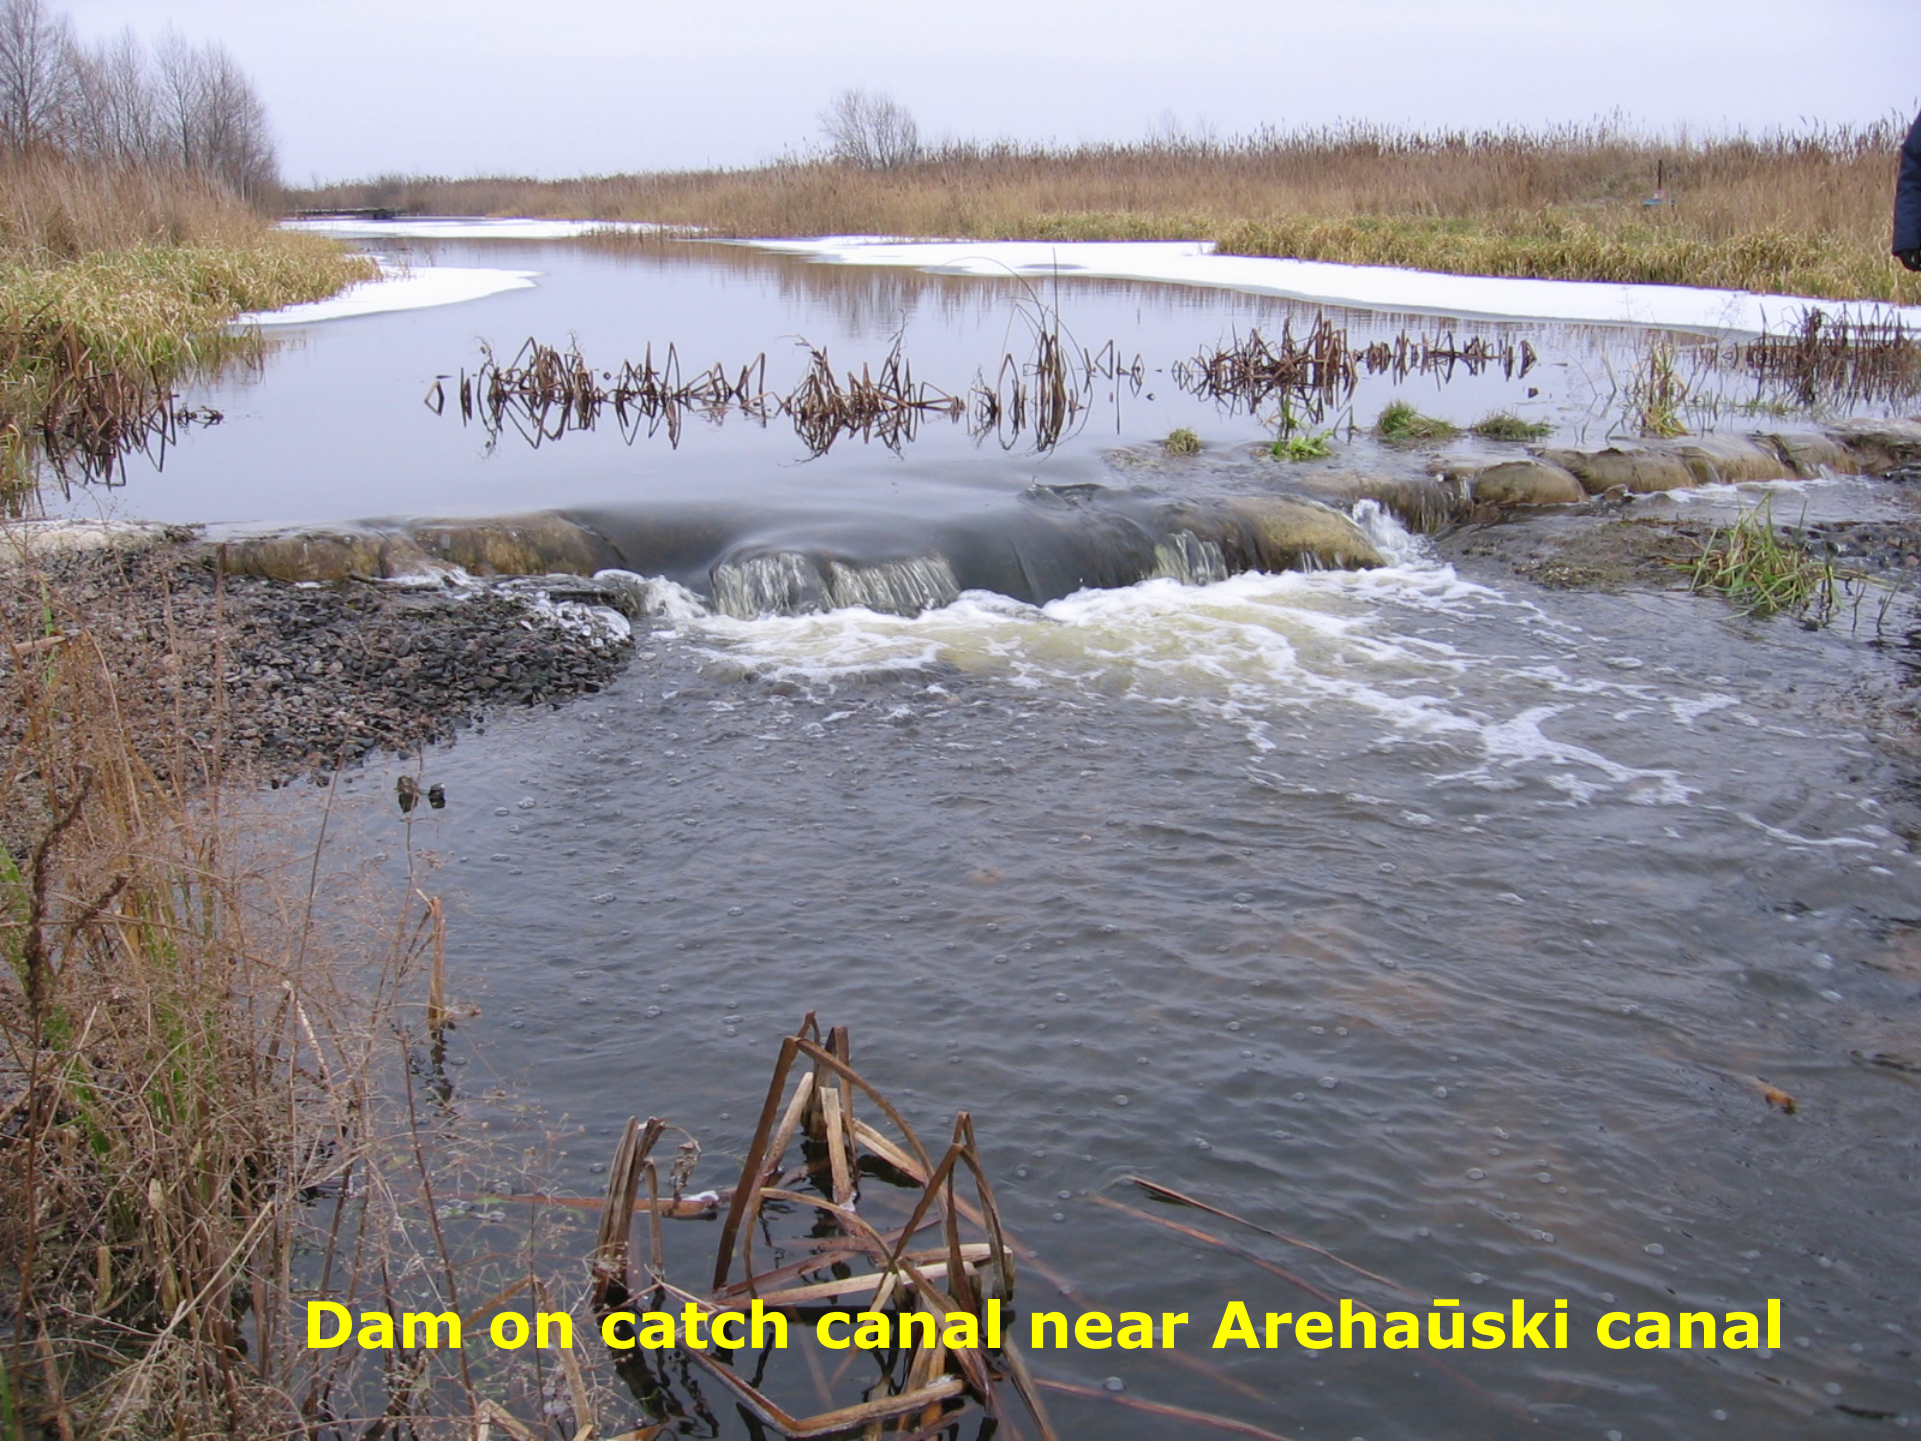
**Dam on catch canal near Arehaūski canal**

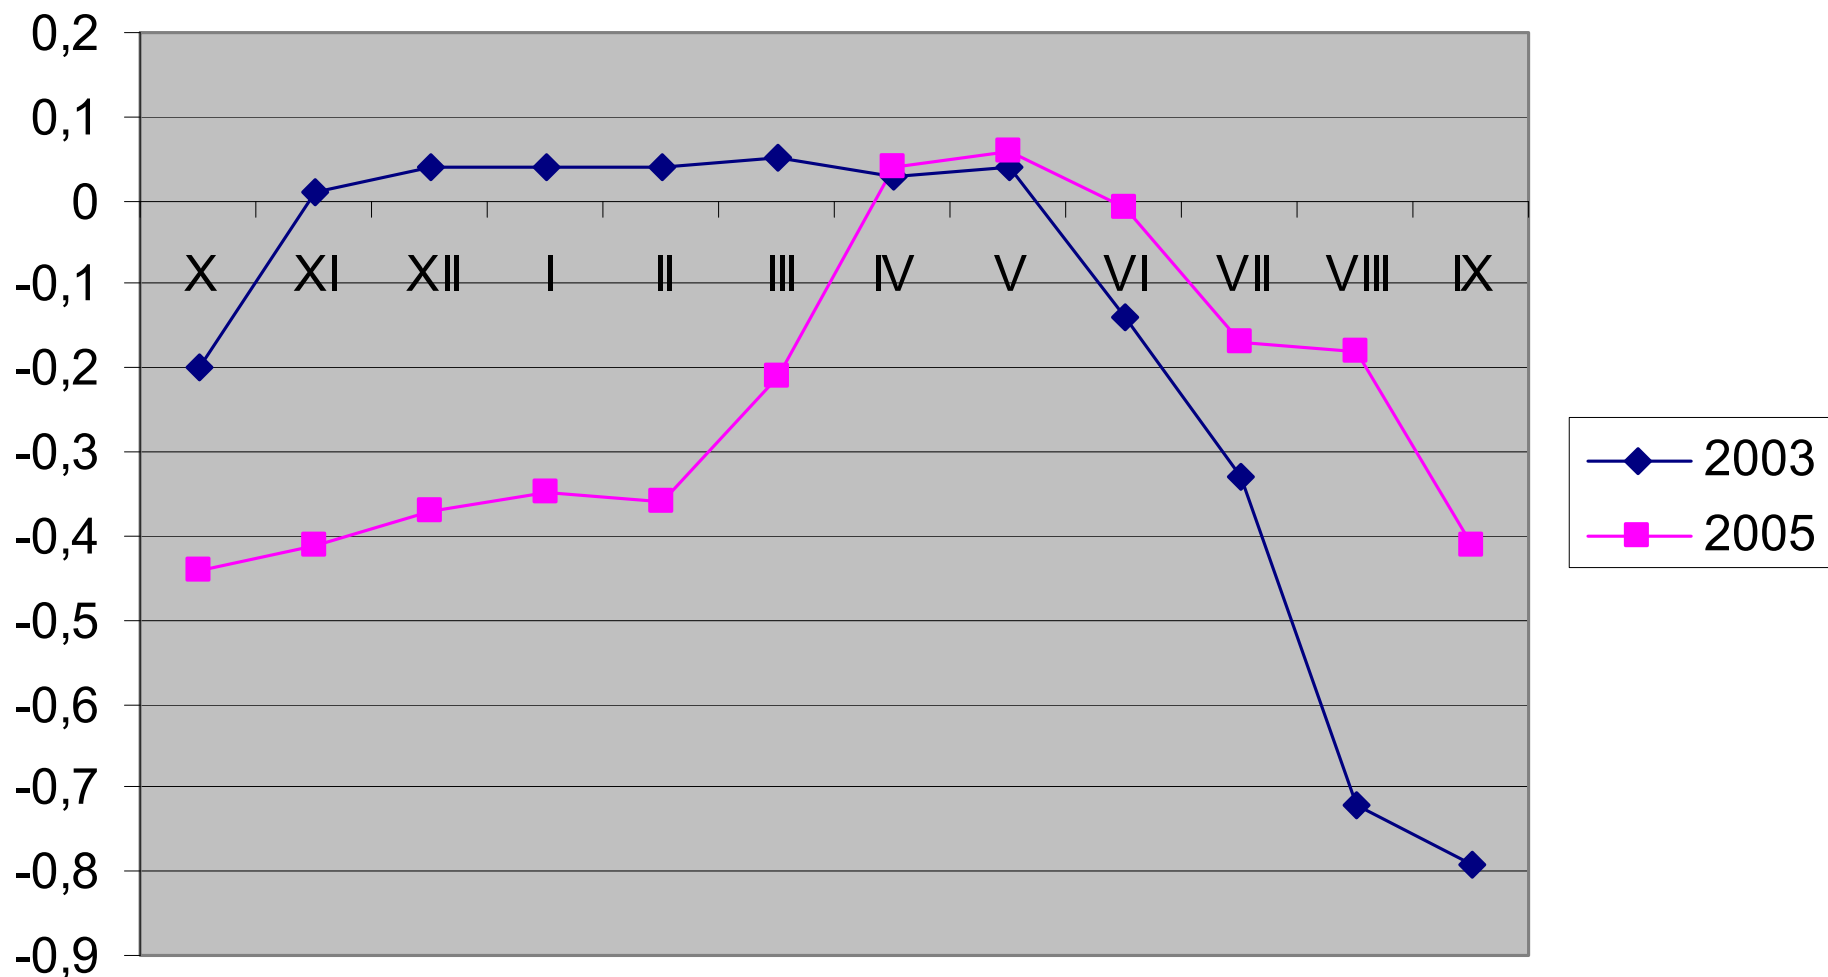
# Dynamics of ground water level at Dzikaje mire

(0 – ground level)

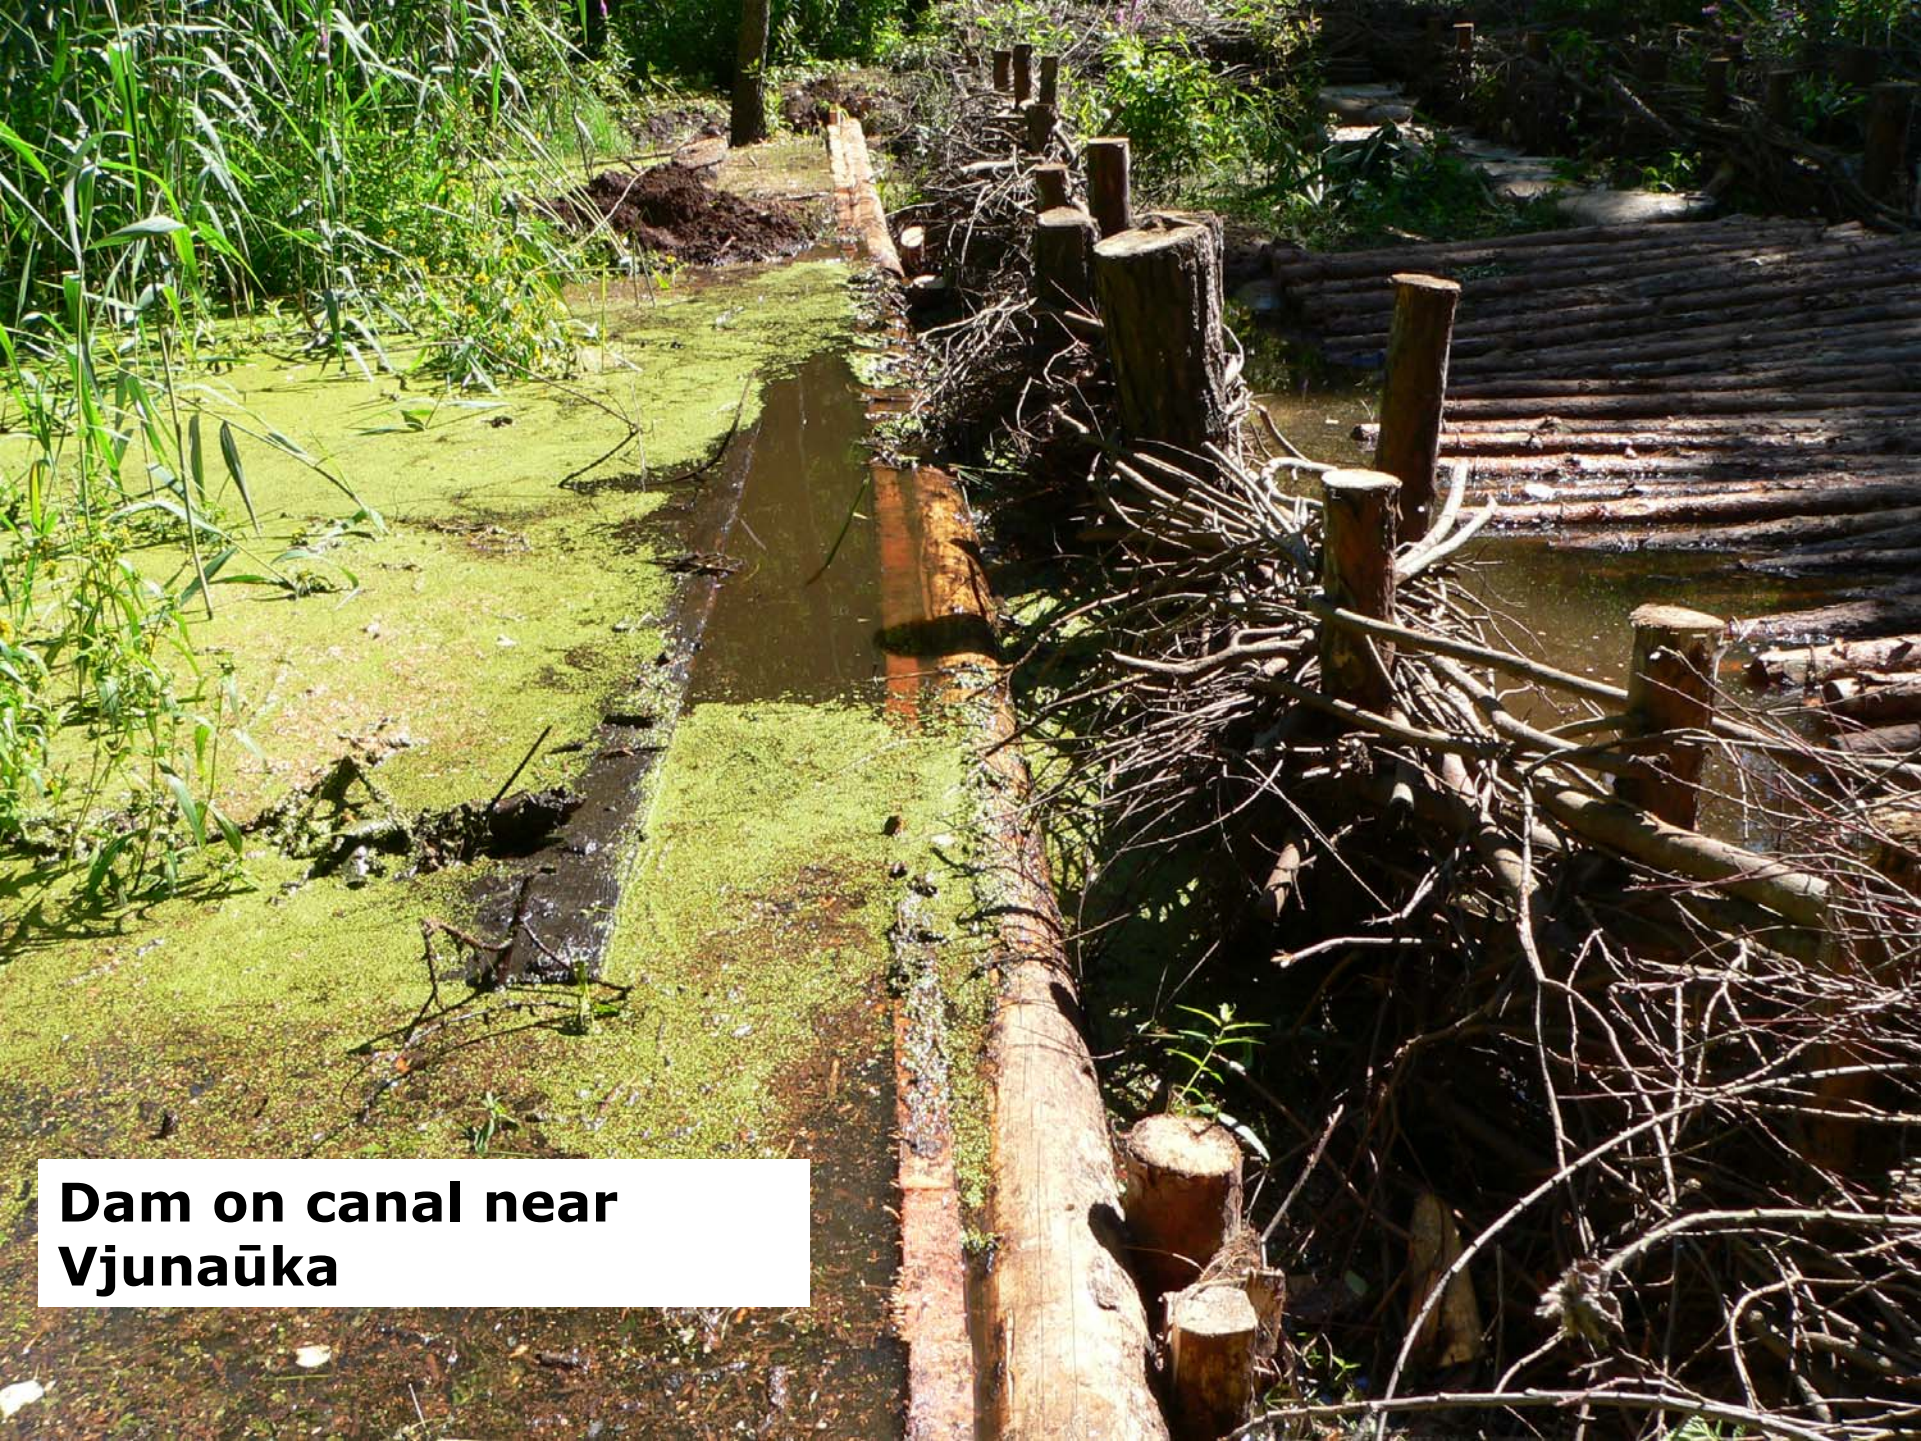
**Dam on canal near  
Vjunaūka**

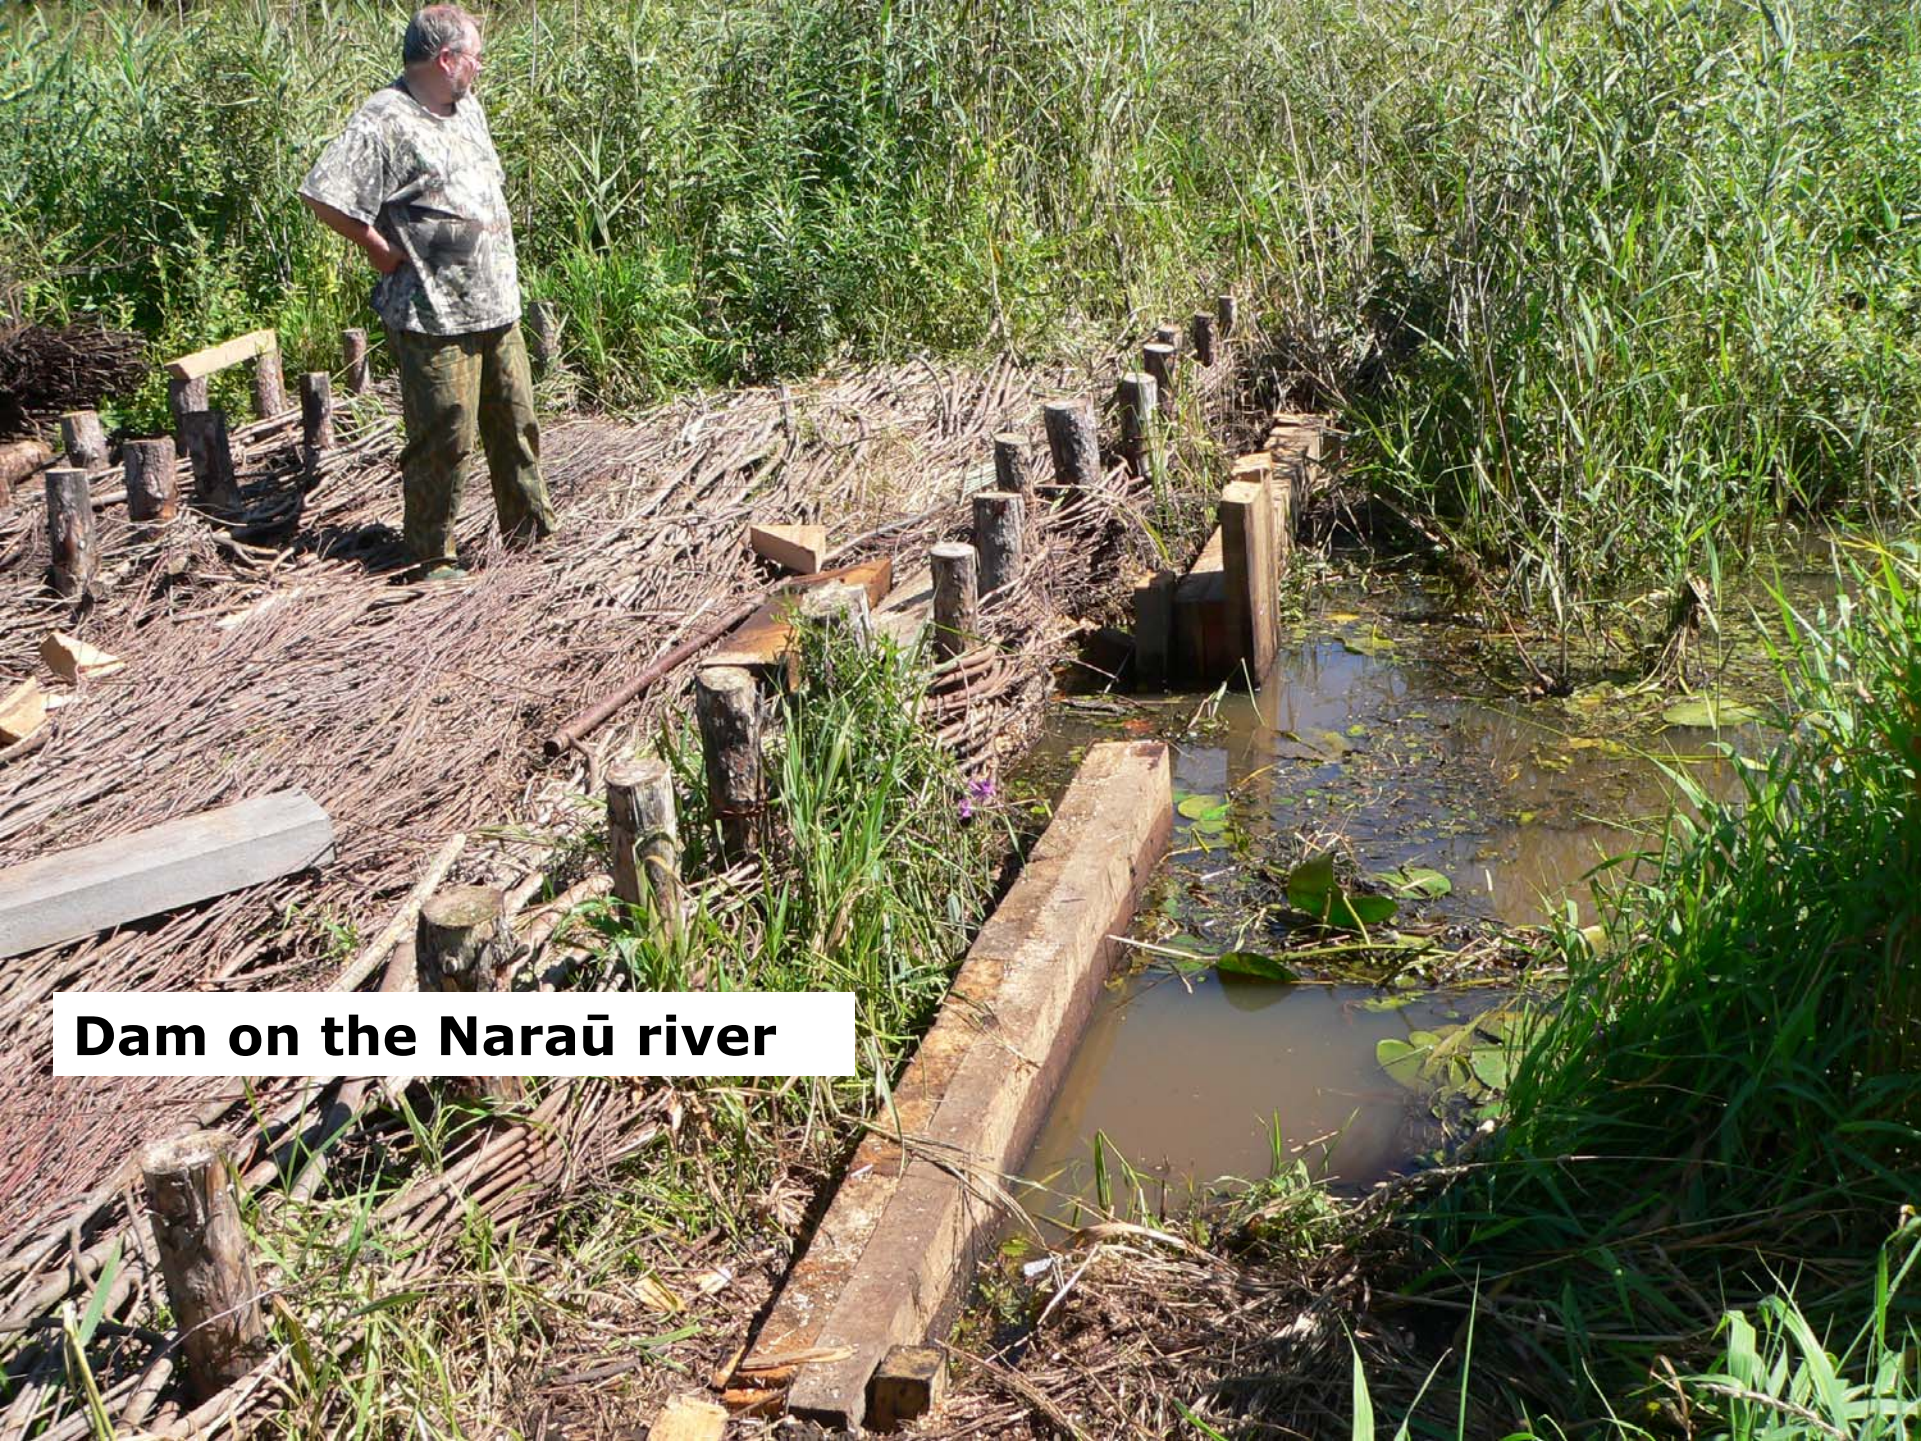
**Dam on the Naraū river**
