# **Management of Aquatic Warbler breeding habitats in Belarus**

**- experiences and conclusions**

## **Implementing urgent conservation actions in mesotrophic fen mires in Belarus**

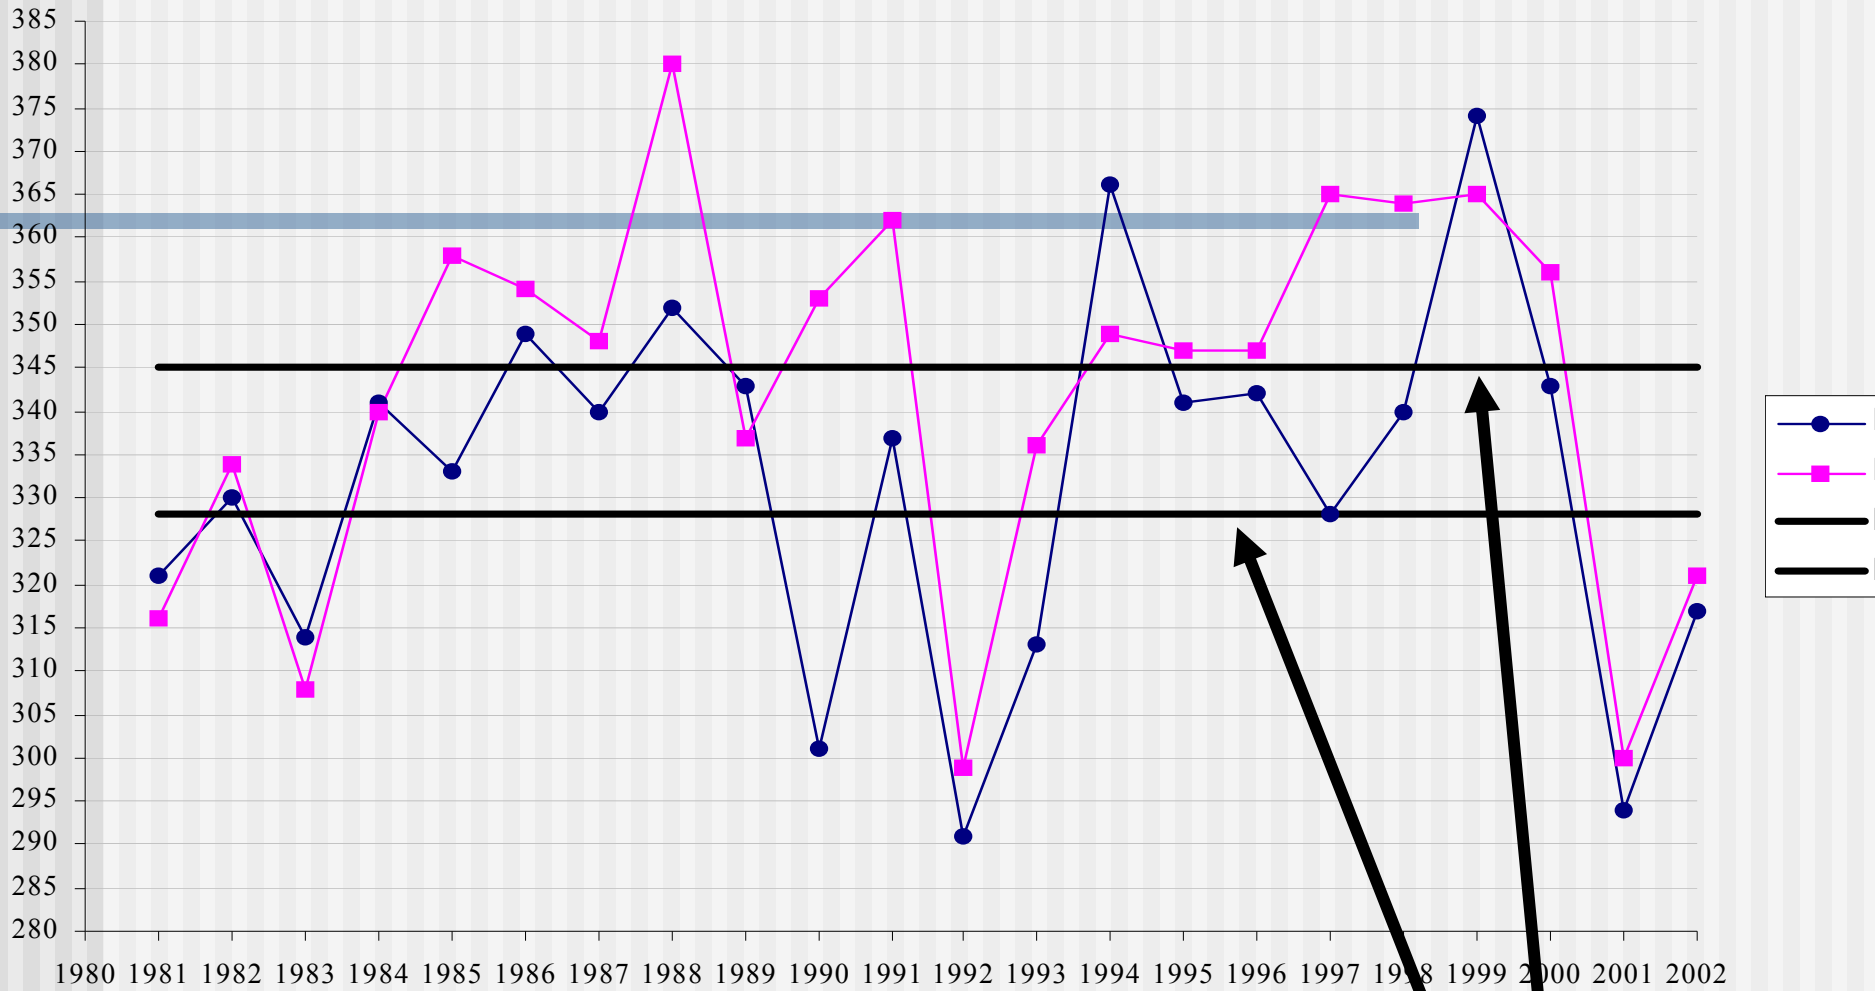
# Dynamics of water level 1st June and 1st July since 1981 till 2002 (monitoring plot at the river Jaseída floodplain)

**11 years – first clutch is successful (47,8%);  
4 years – second clutch is successful (17,3%);**

**Water level  
suitable for AW**

*Optimal water regime of the Jasélda river floodplain:*

- **May-June – 5-10 cm above the ground level,**
- **July – on the ground level.**

- **Flooding higher than 15 - 30 cm,**
- **Decreasing of water level lower than 10 cm below the ground.**

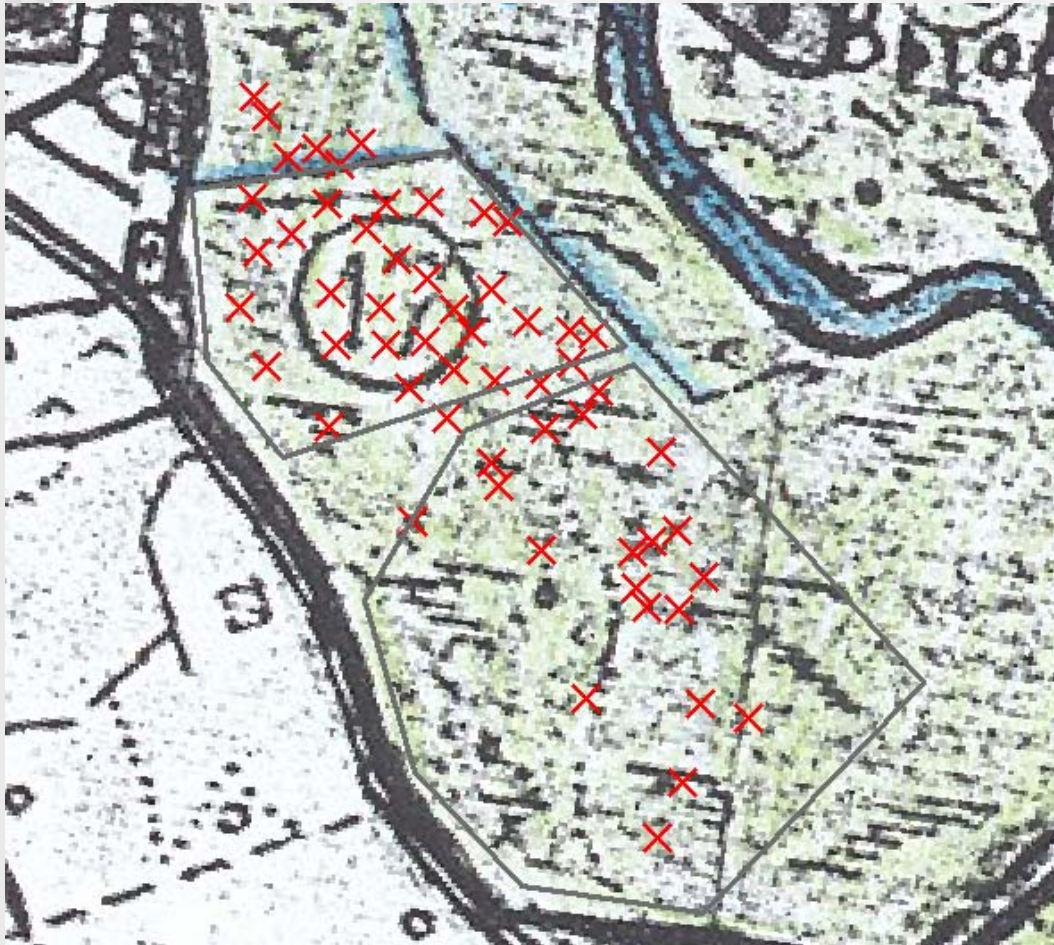
Monitoring plot near the village Kasciuki, according to 2008 census.

Aquatic Warbler density

Mown area	103
Not mown	28

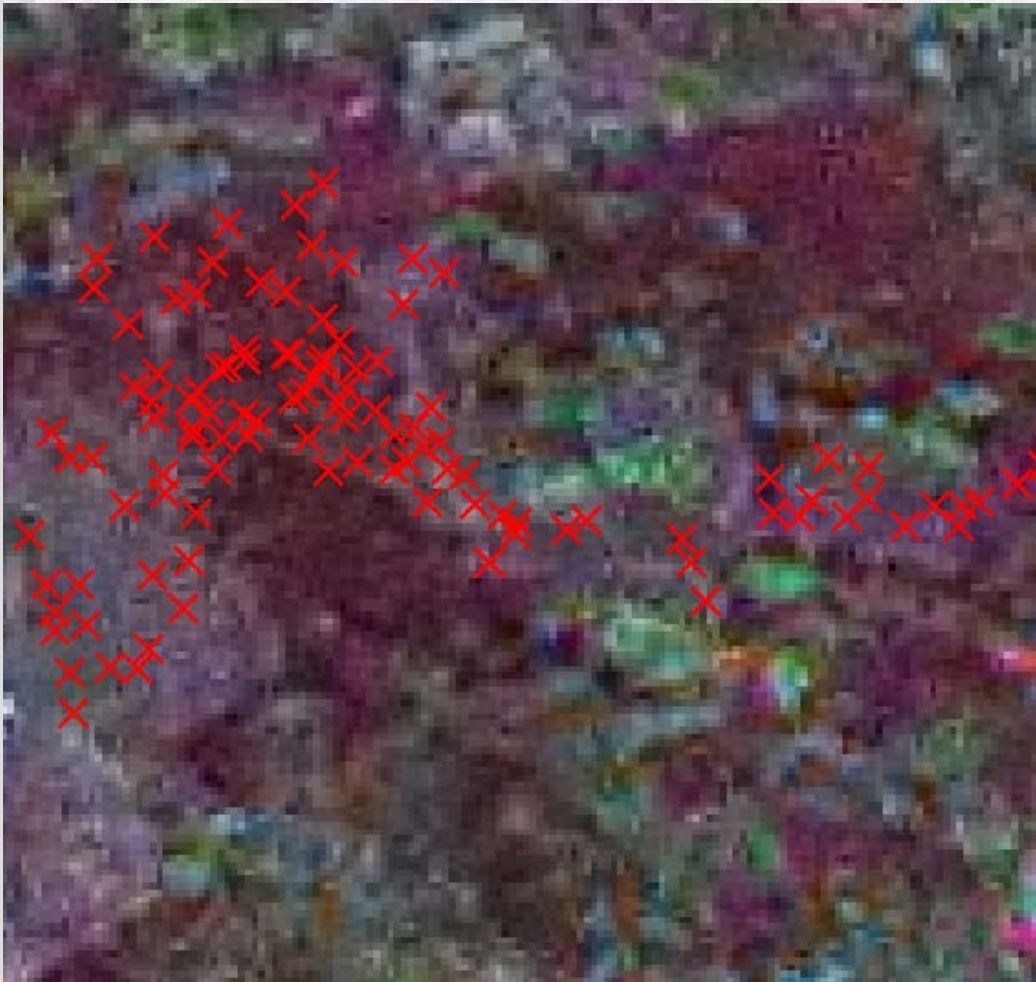
Monitoring plot near the village Kakoryca, according 2008 census

Aquatic Warbler density

Mown area up to	(!) 165
Not mown	0-50
